# Battling Bolts from the Blue

By Guy Meilleur

Much of the 520 acres is covered with row after unbroken row of gravestones, and more will be added until the cemetery is full to the fences. The scattered trees stand sentinel, shading and softening the soldiers' final resting ground. Several are antebellum "witness trees," also veterans of the Civil War. Coordinated by urban forester Eric Gansauer and the Georgia Arborists Association, arborists with TCIA member companies Arborguard Tree Specialists and Downey Trees joined dozens of others to care for these veteran trees that watch over the graves of fallen veterans. This article is about one tree in particular that serves to remind us of something near and dear to arborists' hearts—the importance of tree preservation. Following is a report on that tree, No. 263:

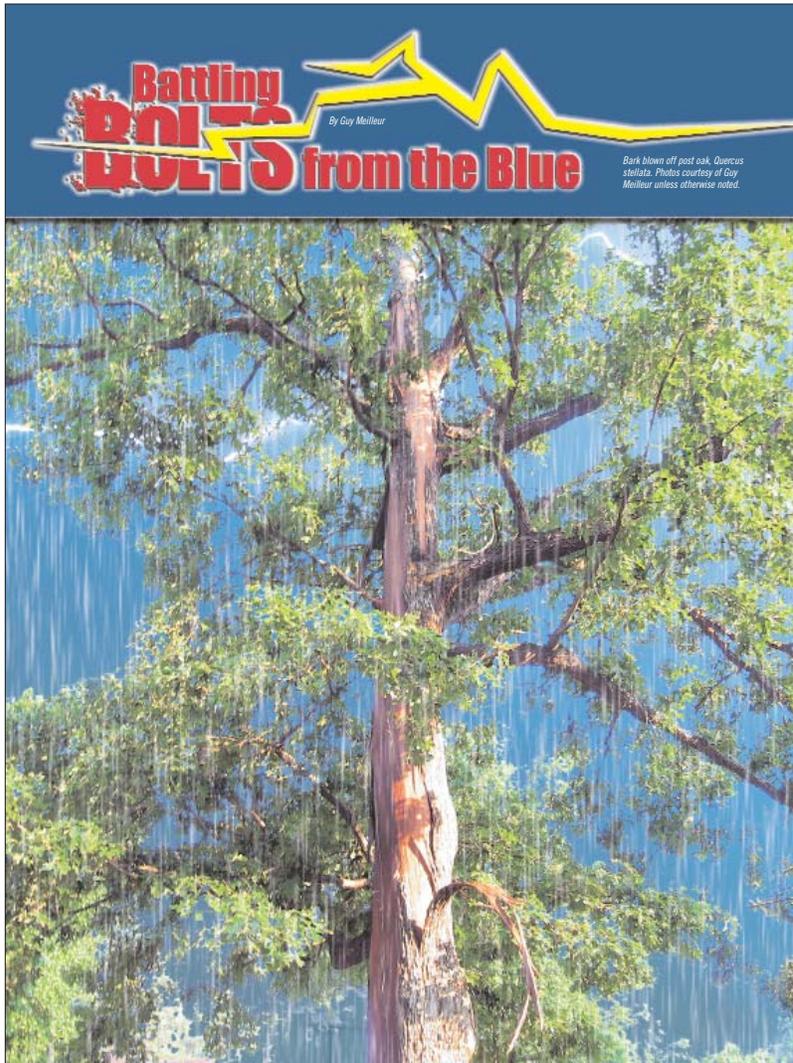
Bark blown off post oak, *Quercus stellata*. Photos courtesy of Guy Meilleur unless otherwise noted.

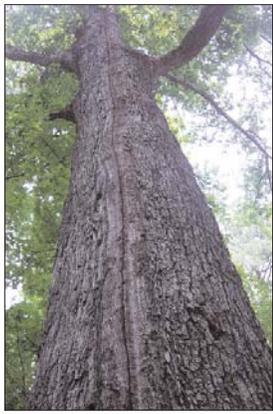
Ten-inch lightning wound on mature white oak, *Quercus alba*, closed after four seasons of tree care.

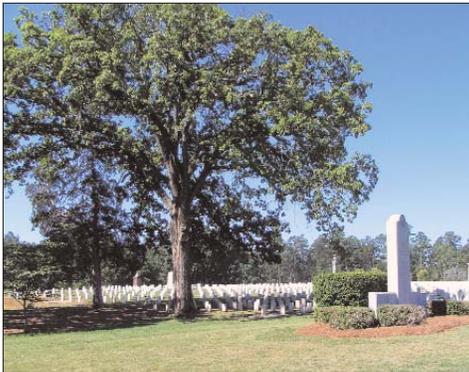
I noted four separate streaks of wood down the stem of tree No. 263, at approximately right angles to each other. The widest wound ran from the base up to the first primary fork on the northwest side and back down the other side. A small crack started at that fork, and there was active decay in a pocket above the crack, just below the fork. A large, fat sink was living under the detached bark.

I used a hammer to test the trunk of tree No. 263 for resonance at 4½ feet above the ground. Fifty-two inches of bark circumference sounded hollow. The bark came off easily because it was dead. One hundred and five inches of the circumference sounded alive. Unidentified wood-boring insects were active underneath the loose bark — but not in the exposed areas where the wood was dry. The wound above the primary fork was more than 20 inches wide. A probe went 6 inches through mushy tissue at the fork.

With one-third of the bark blown off the trunk, and a 20-inch-wide wound above the first fork, this lightning damage seemed terminal. This fork seemed at risk to fail in a moderate summer storm, but it could be cabled to buy some years. However, it is only a matter of time before cracking and decay render the lower trunk unstable. Poor root health and more excavation for graves mean this time will come fairly soon, despite the wood's resistance to

Tree No. 263 posed a high risk in the near to medium term. The long-term risk

Tree #263 at Andersonville did not recover from lightning wounds. It will be felled by the friendly fire of chain saws.

Superintendent Boyles made the tough decision to remove tree No. 263. He also made a much easier decision – to apply for funding to protect the remaining landmark trees from future lightning strikes.
