Historic Tree Care

Great Falls Oak Tree Risk Assessment 121007

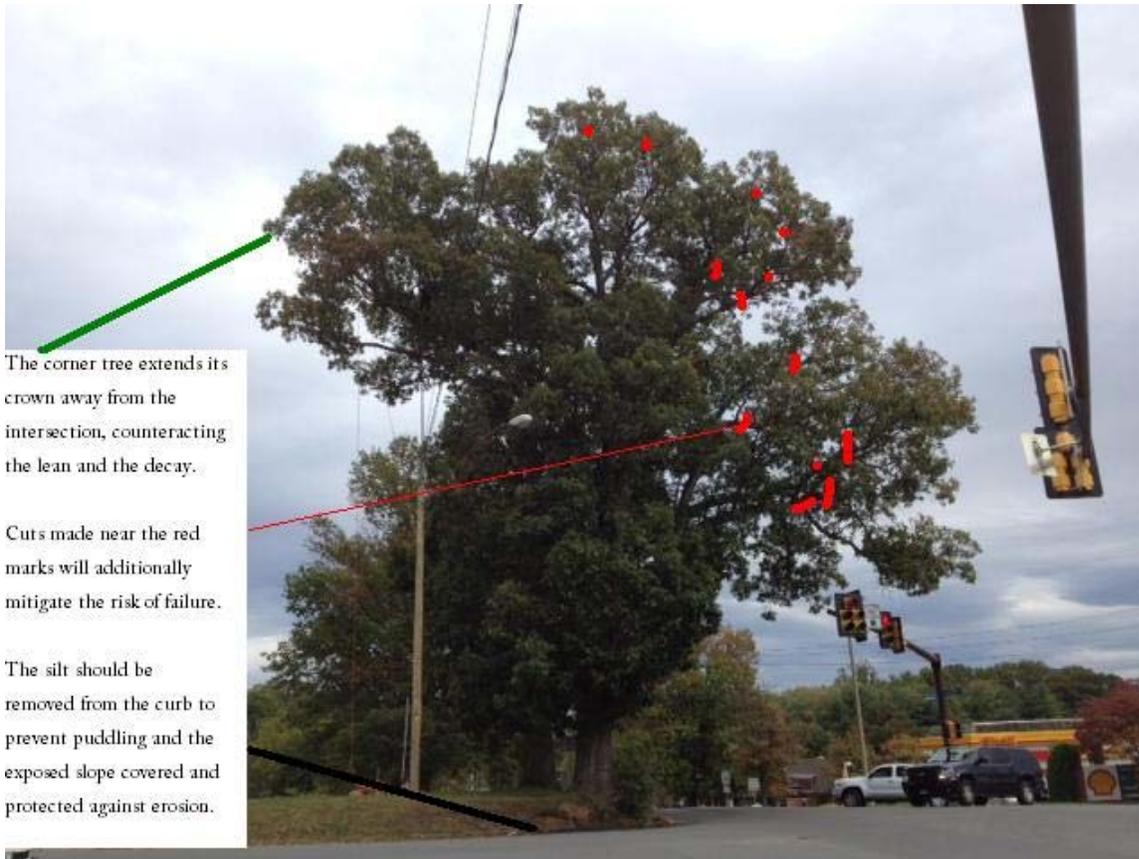
The flare of the corner oak has 5’ of its 16’ circumference damaged by grading. Roots were cut over 2’ inside the curb, apparently by VDOT or its contractors when the road was widened. Some decay is visible inside of some of these grading wounds, but woundwood is growing around each of these small cavities. Resistograph readings indicate decay over 9” deep on the northeast side and over 12” on the east side, where the grading damage is most severe. Away from the road, the buttress is relatively intact, and we saw and heard no signs of infection. The integrity of the roots extending parallel and away from the road was consistent or stronger, according to sounding tests. No scavenging or invasive pest was seen feeding on the outside of the corner oak.

The corner oak is leaning over the intersection.

The corner tree extends its crown away from the intersection, counteracting the lean and the decay.

Cuts made near the red marks will additionally mitigate the risk of failure.

The silt should be removed from the curb to prevent puddling and the exposed slope covered and protected against erosion.
