US Champion White Oak: European Treatment

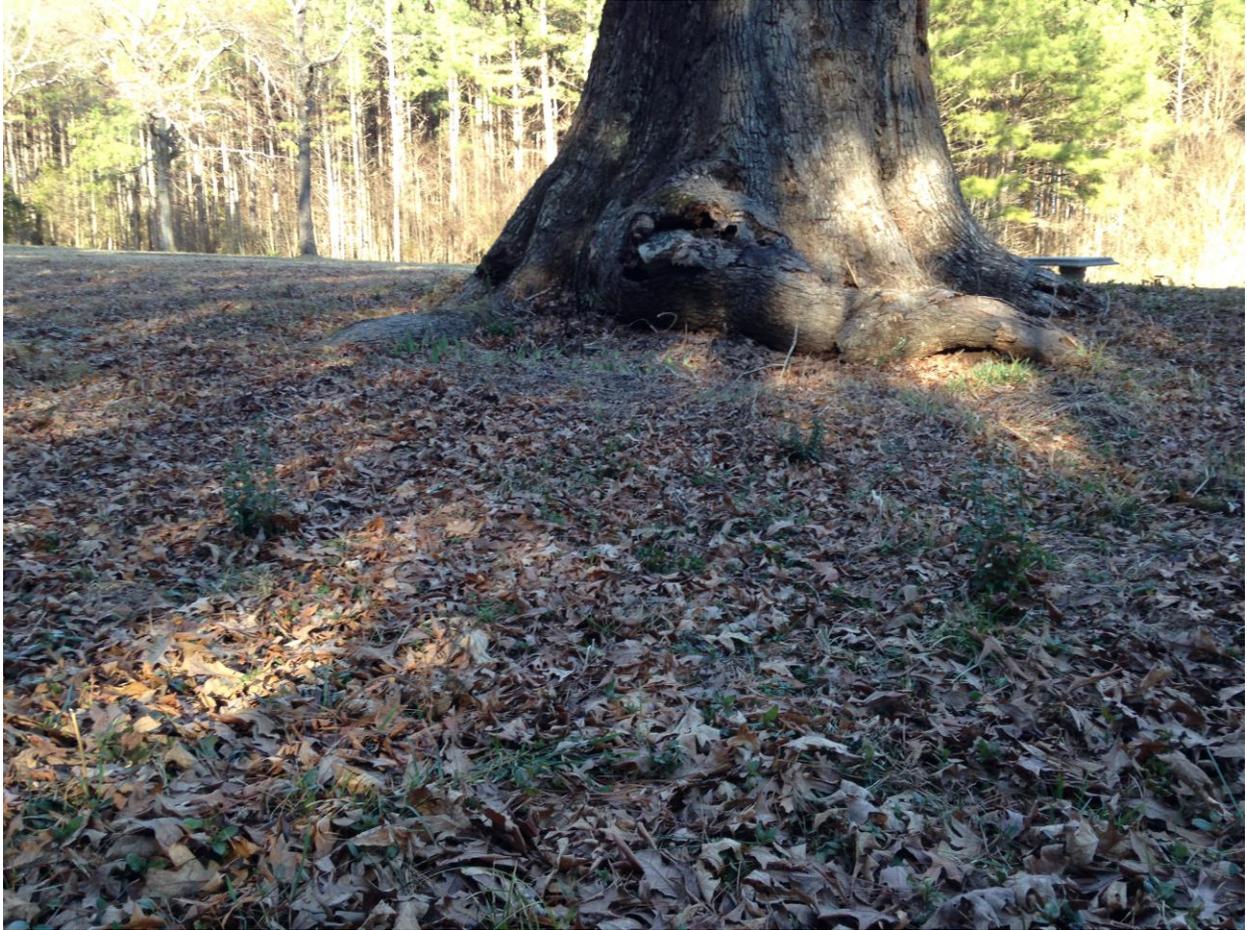
Roots are covered from the driveway to the woods by 'mixed turf'. The owner keeps it mowed close, in a battle against woody weeds. Mowing seems to encourage privet, the three green clumps shooting upward. If the roots cannot be pulled out, a low cut with loppers followed by mechanical suppression, as with a flat stone, can do a good job on this invasive weed. The closer you get to the trunk, the smaller a part that grasses play. In his seven years of residence, the owner reports no disturbance underground.

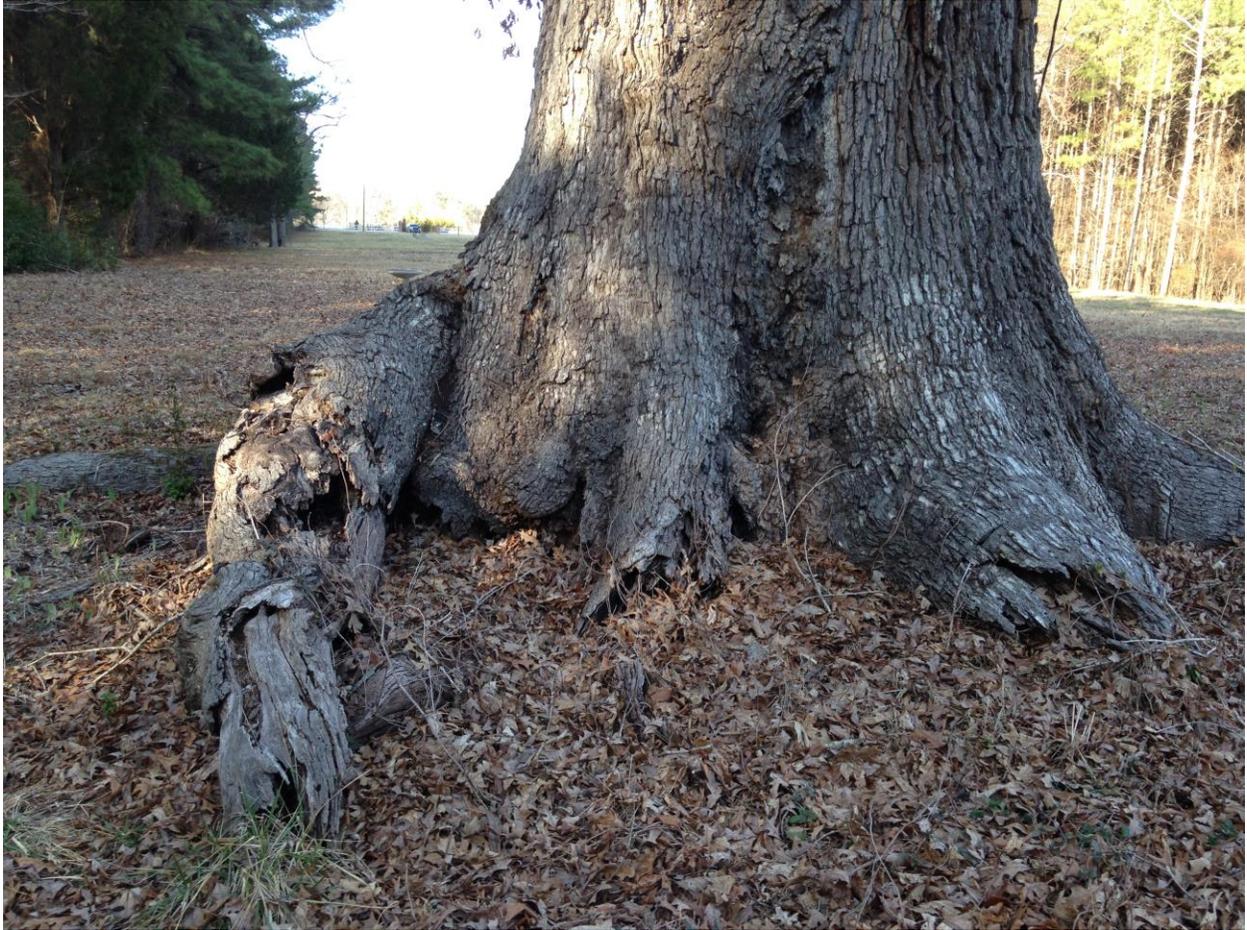
The buttress roots to the south look like they were hurt a long time ago. The westward one girdles the stem well above grade and sustained major mechanical damage. The other three have a typical form and less scarring. It looks like they just wasted away. Facing the house, soil compaction on this side of the trunk is inevitable, so the #1 ingredient specified will be air. Pressurized air and water will open holes and fracture subsoil two foot deep and more. Composted oak leaves, twigs and acorns blended with porous aggregate will be poured back in, to maintain aeration and boost fertility. Soil probing and analysis will indicate what other amendments might fit the site.

After the area's raked smooth, identify the most compatible groundcover, such as nitrogen-fixing or tap-rooted species to preserve where they meet the objective. A layer of cardboard will suppress the competition, with an inch or two of chipped oak branches and acorns and leaves on top. The rest of the flare will be surrounded by the same surface layers, extending to the outermost root that protrudes above the surface. Any future soil work should be gradual, to avoid shocking the tree system. The roots of some native bulbs and wildflowers are chemically compatible with oak. Adding companion plants to the unmown area as it expands over time might also help the oak by attracting beneficial insects.

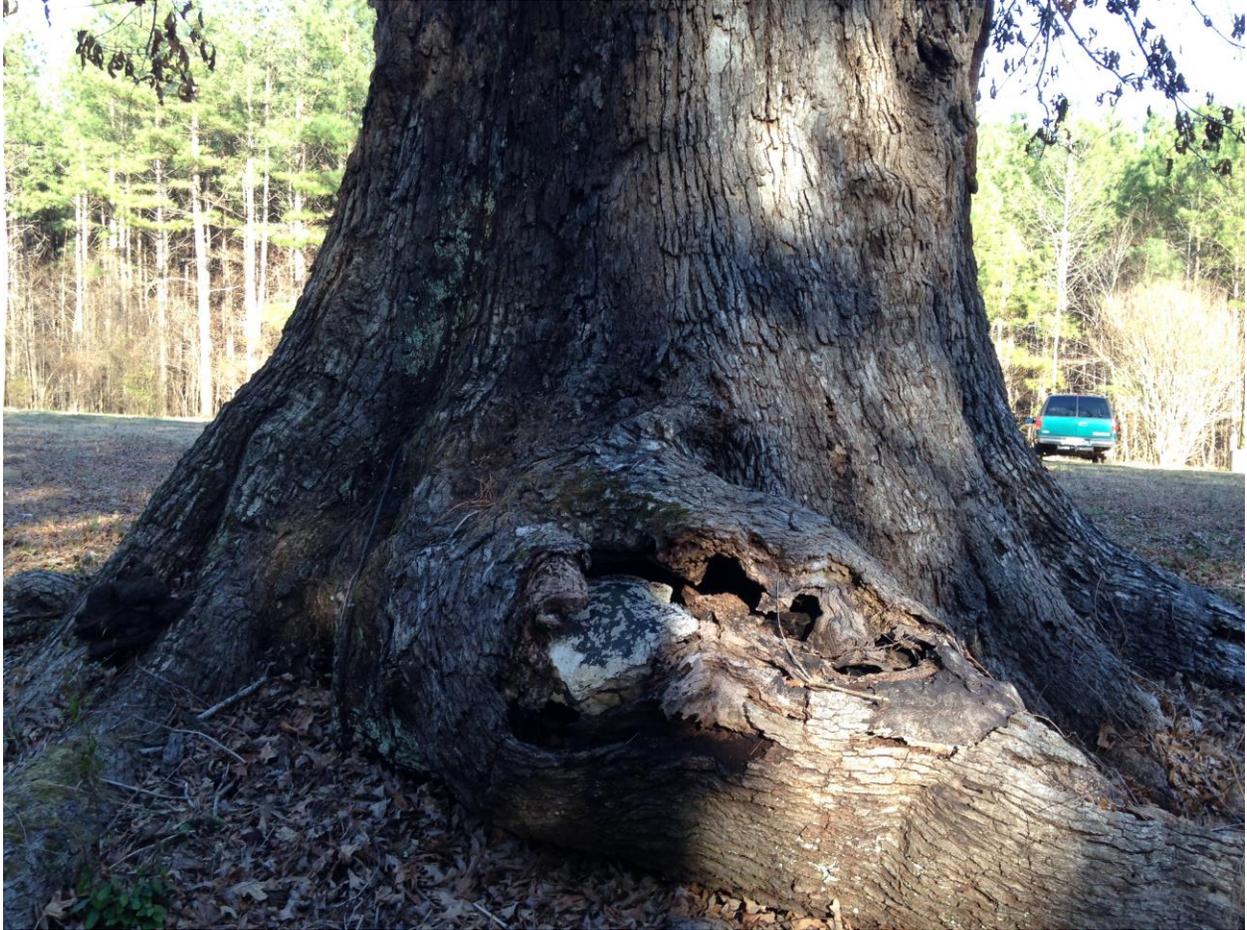
Trunk decay is evident in decrepit fungal fruiting bodies to the left, in a sinus between two vascular columns that extend from the earth to the sky. 2' high and 1' wide, the conks being shed from that hollow-sounding area resemble *Inonotus dryadeus*. Located in the next sinus north of the stem-girdling root, with the ancient concrete filling inside it and the lighting conductor alongside it, the conks indicate that interior decay is extending northward. However, the squat form of this tree, and its sparse crown weighted away from the domicile, lowers its risk potential. Assessing the buttress roots, this tree has 9 intact and 3 decayed, ~75% still functional and supportive. Moving on!

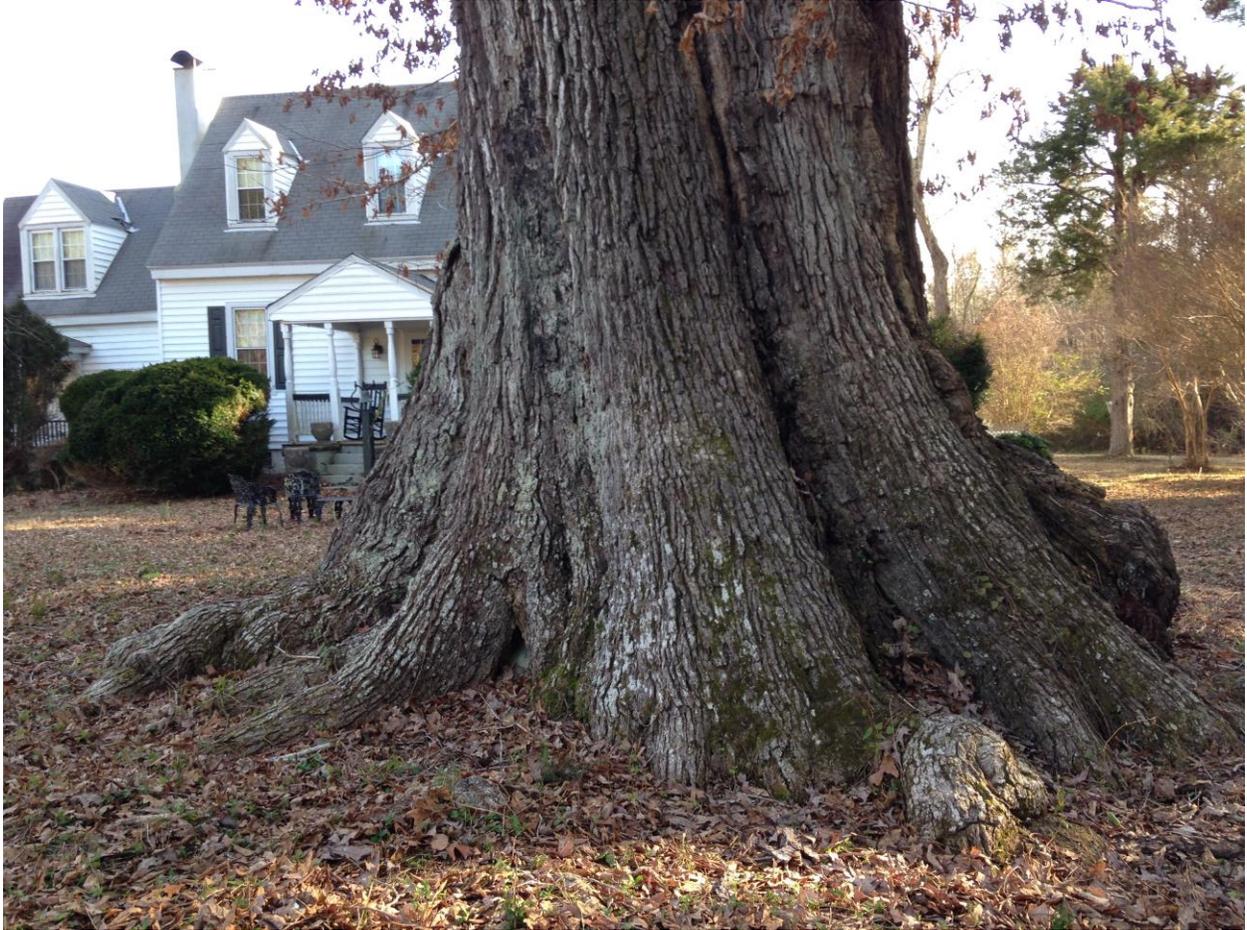
The north view shows a dysfunctional sinus ending in a seam >10' above grade. Lightning damage was theorized, but evidence is inconclusive. No continuous seam can be traced from flare to apex, but most of the upper crown is gone. Time, and callus, heals all wounds. Aerial assessment might indicate lightning; it might not. Being the tallest thing around in its day, that would be no surprise. The mallet yields no hollow sound outside the sinus, in the two columns arising from the buttresses, so compartmentalization seems to be effective. The growth of these buttresses and the response growth in the burl show that the tension side is anchoring the tree, and preventing failure in the direction of the ~380-year-old building. Moving on!

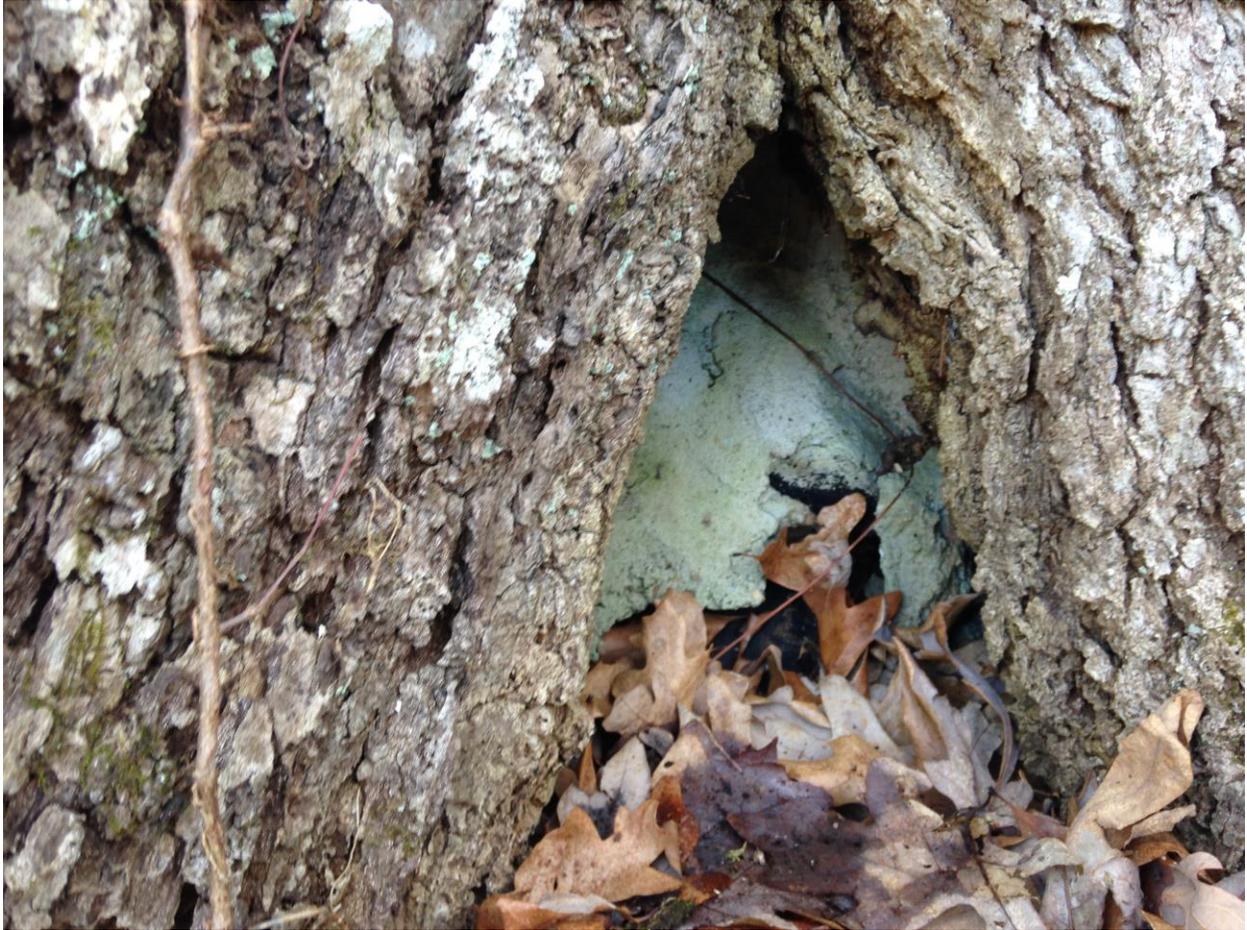
Concrete inside the next sinus to the north indicates this cavity is quite old. The fungus and the tree have coexisted for a long time. White and green growth on the bark are epiphytes. Lichens and mosses are associates of the tree, as is the vine creeping upward. Loose material could be removed from this crevice and relocated to the dripline, but no excavation should be done at this early stage. It would be nice to find the woundwood on both sides of the cavity without digging too much. A long probe inserted into this cavity might come out the other side, but that would not be abnormal for a tree of this age. No invasive probing is warranted.

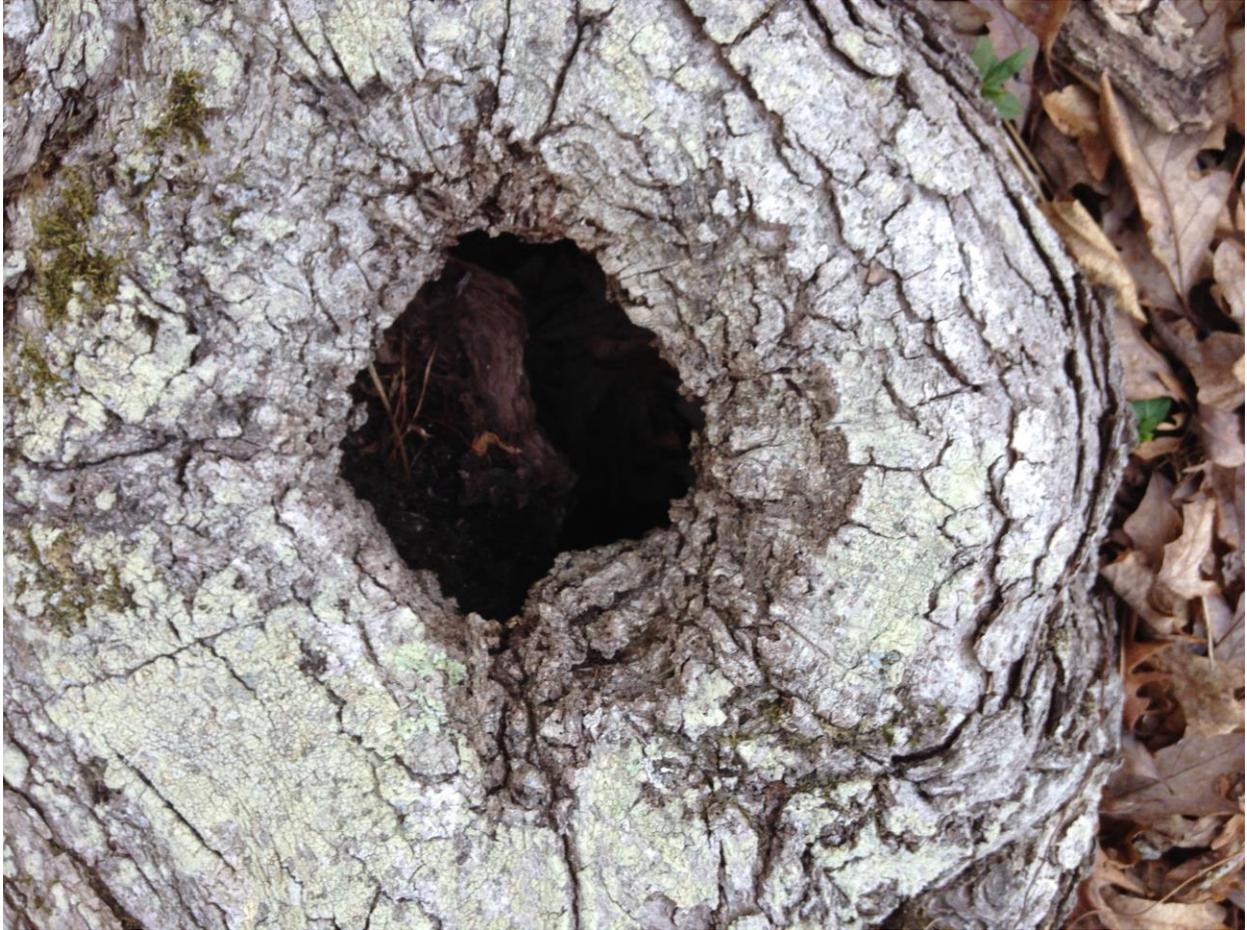
A hollow has formed inside of one mower-damaged buttress root. Inside are signs that other creatures have moved in, to occupy the space once held by wood. Open to spores and wind and water, mower wounds are far more damaging than they get credit for.

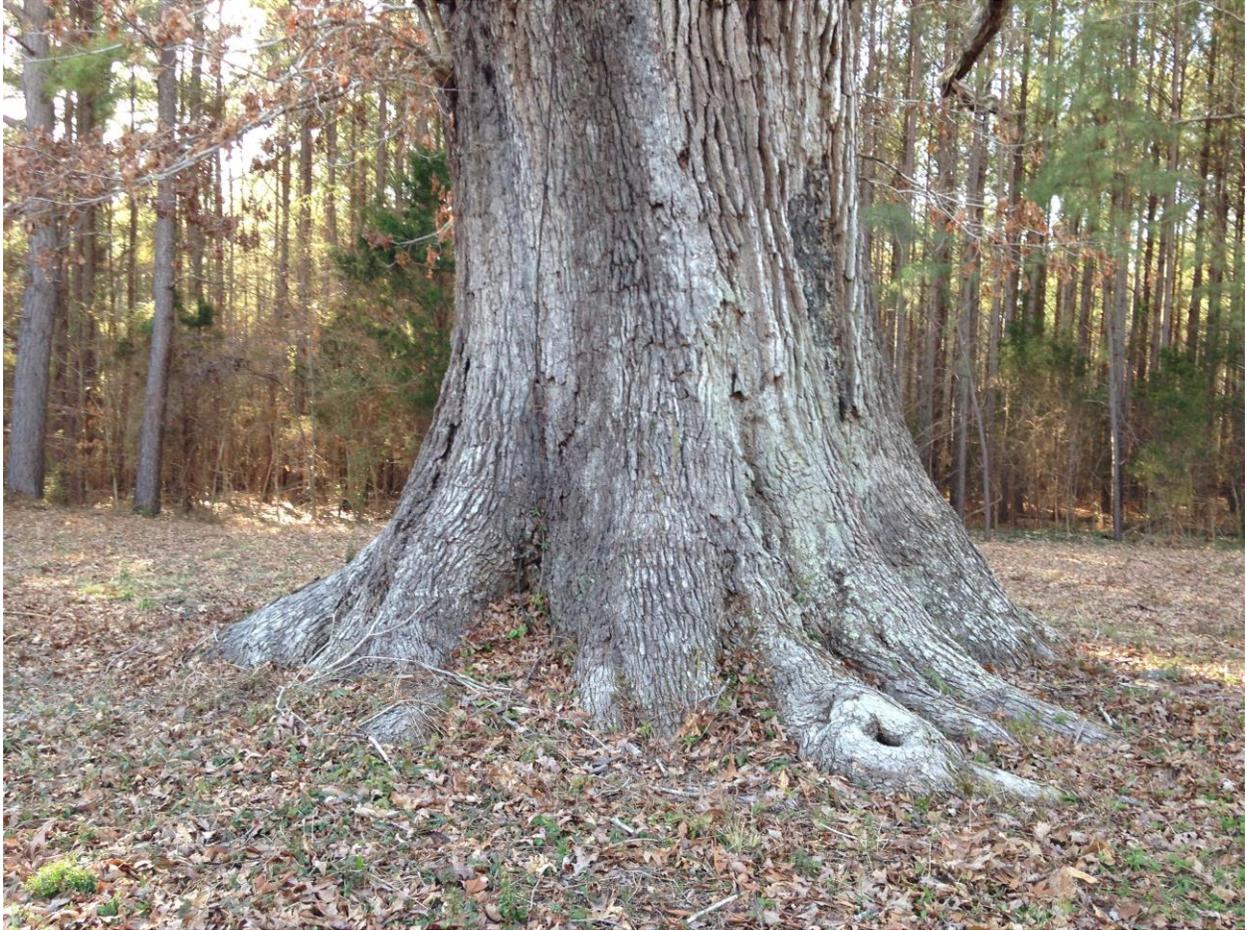
The eastern view shows an intact base, other than that thickly-ringed hole in the buttress root. The black area to the right is the dysfunctional sinus, with high ridges of bark appearing unaffected on either side. The sinus to the left has a seam above, but no dysfunction evident to the eye or ear. The piney woods beyond could use some thinning, though.

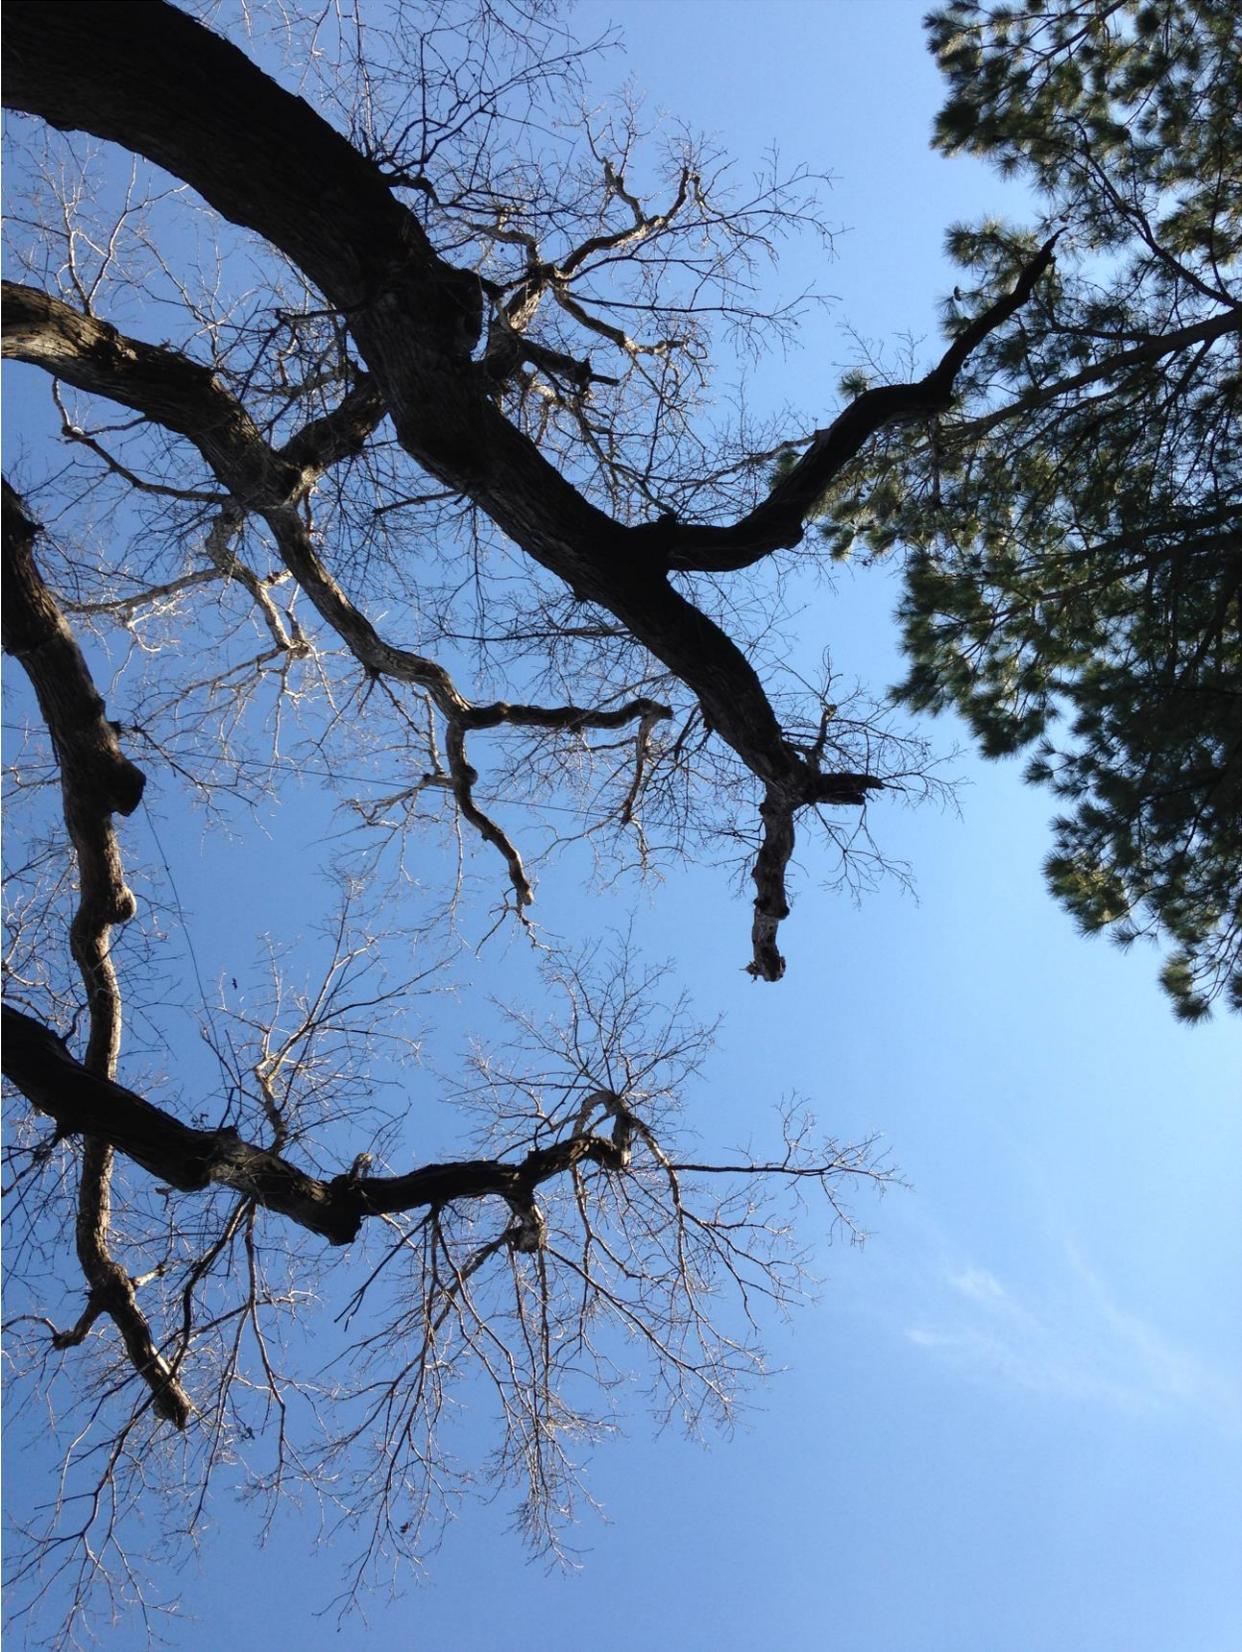
Crown damage may have been caused by overengineered cables, but this work was likely done before there was a national standard for supplemental support. This leader lost its ends after the cable held it rigid. For present purposes there is no maintenance required, other than to avoid the area under the dead stub. New growth looks vigorous outside the shade from the pines. One-third of the suppressing pines should be removed every 3 years.

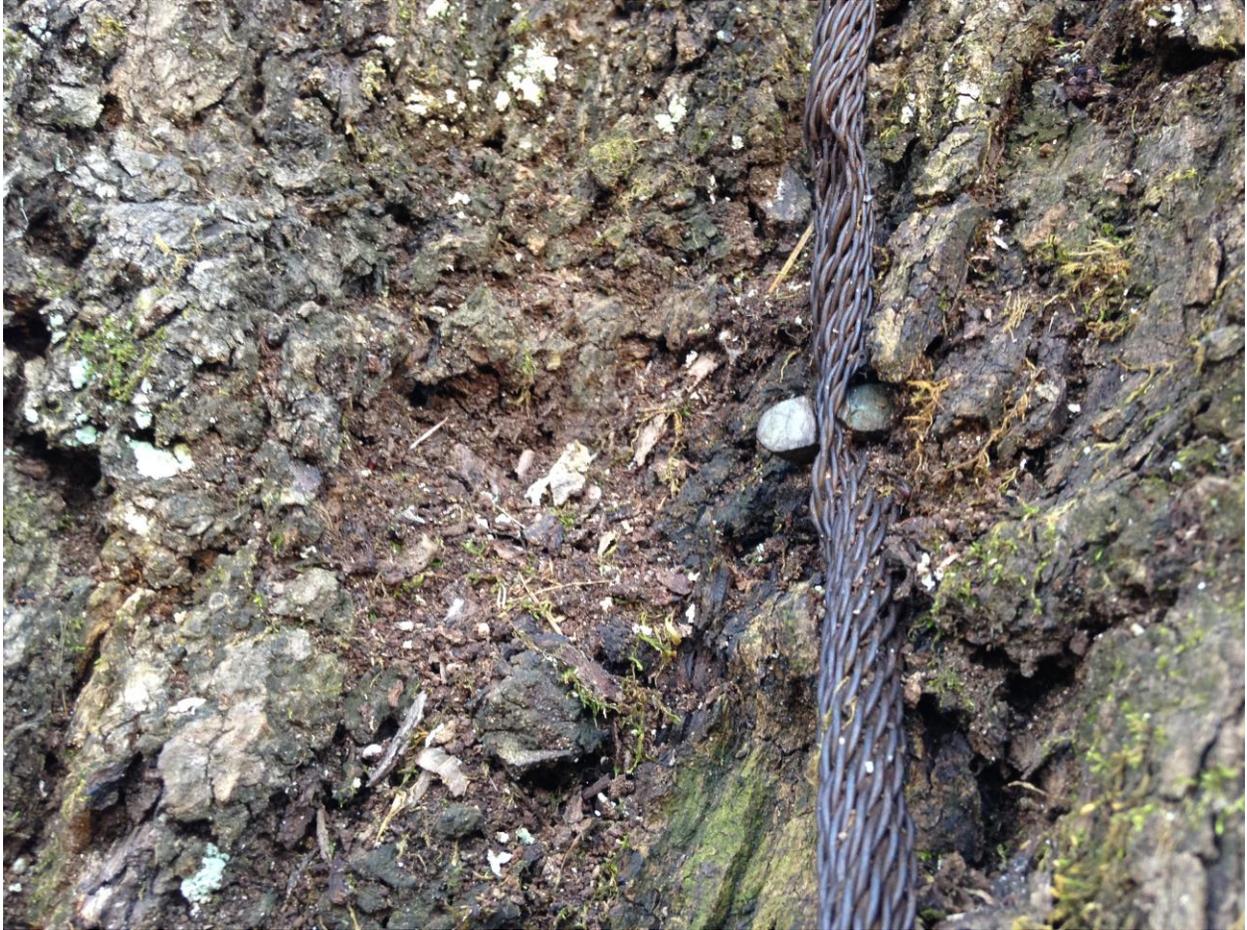
The lightning protection system is broken above, and swallowed below. Fasteners must be replaced, conductors should be held outside of the bark. Compromised sections can be 'bridged' with new conductor to supplement the old, new fasteners preferably in contact with the old.

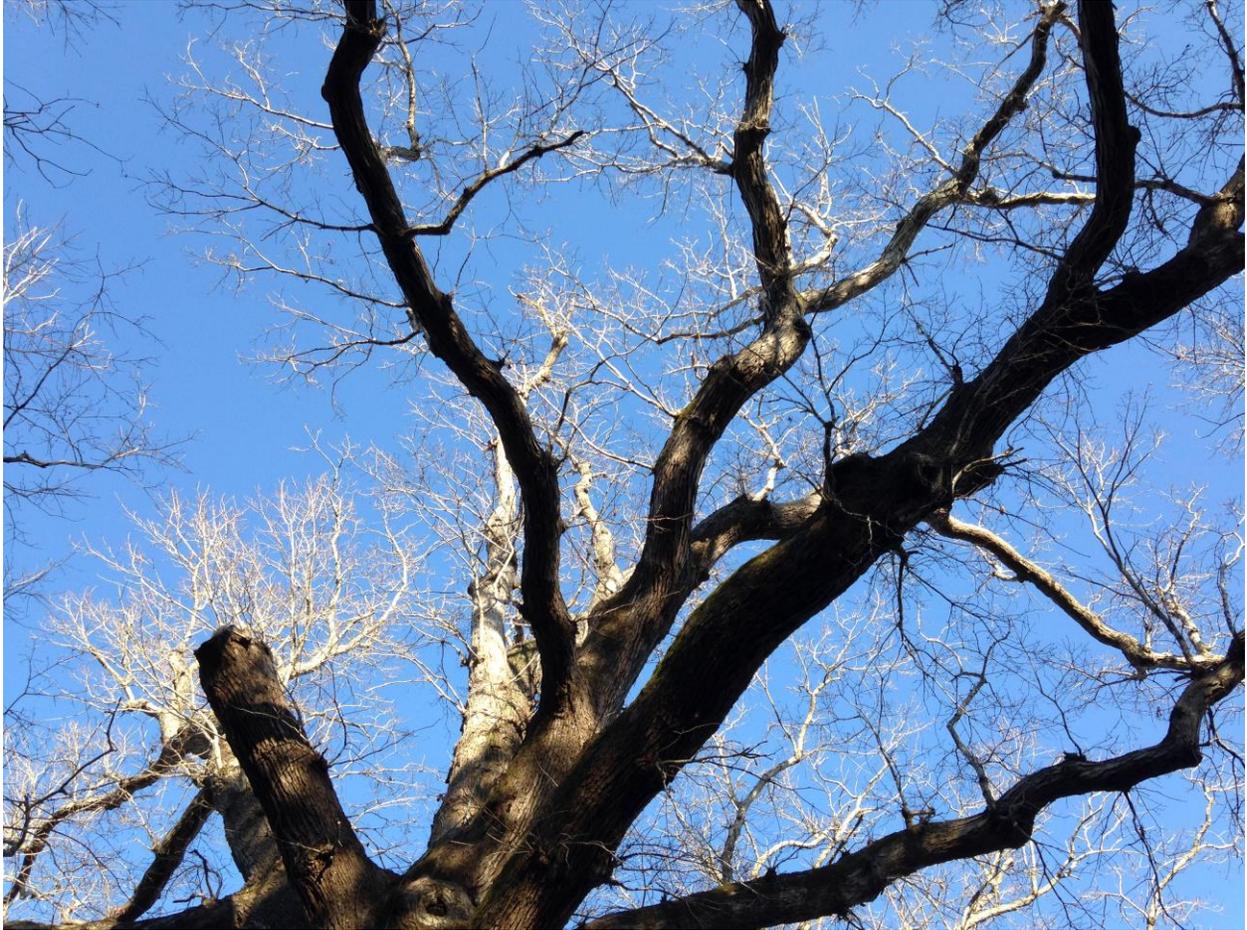
The stub to the left may have been as high as the storm-damage-repair crew could reach; natural breakage is seldom that low. The loss cost the tree a lot of crown volume, symmetry, and resources. Light tip reduction of two branches are the only pruning needs seen from the ground.
