US Champion White Oak: European Treatment

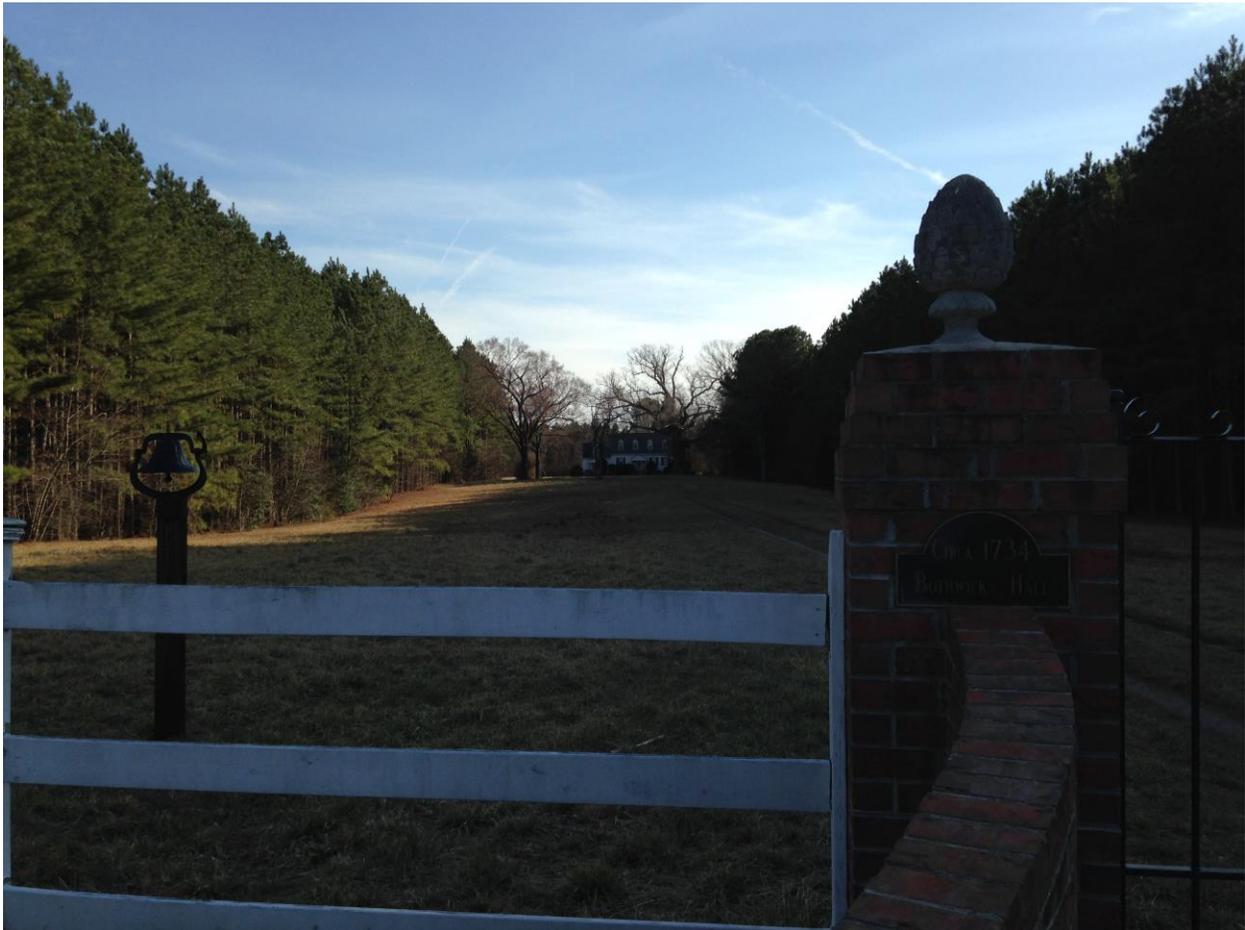
The narrow county road passed well-established farms, with recently-built residences looking small, beyond huge, flat lawns. Even on a foggy February day, from the road a football-field distance or more away, the oak's dimensions were impressive. It towered around the two-story dwelling behind it, and might have been sizable when the house was built circa 1734.

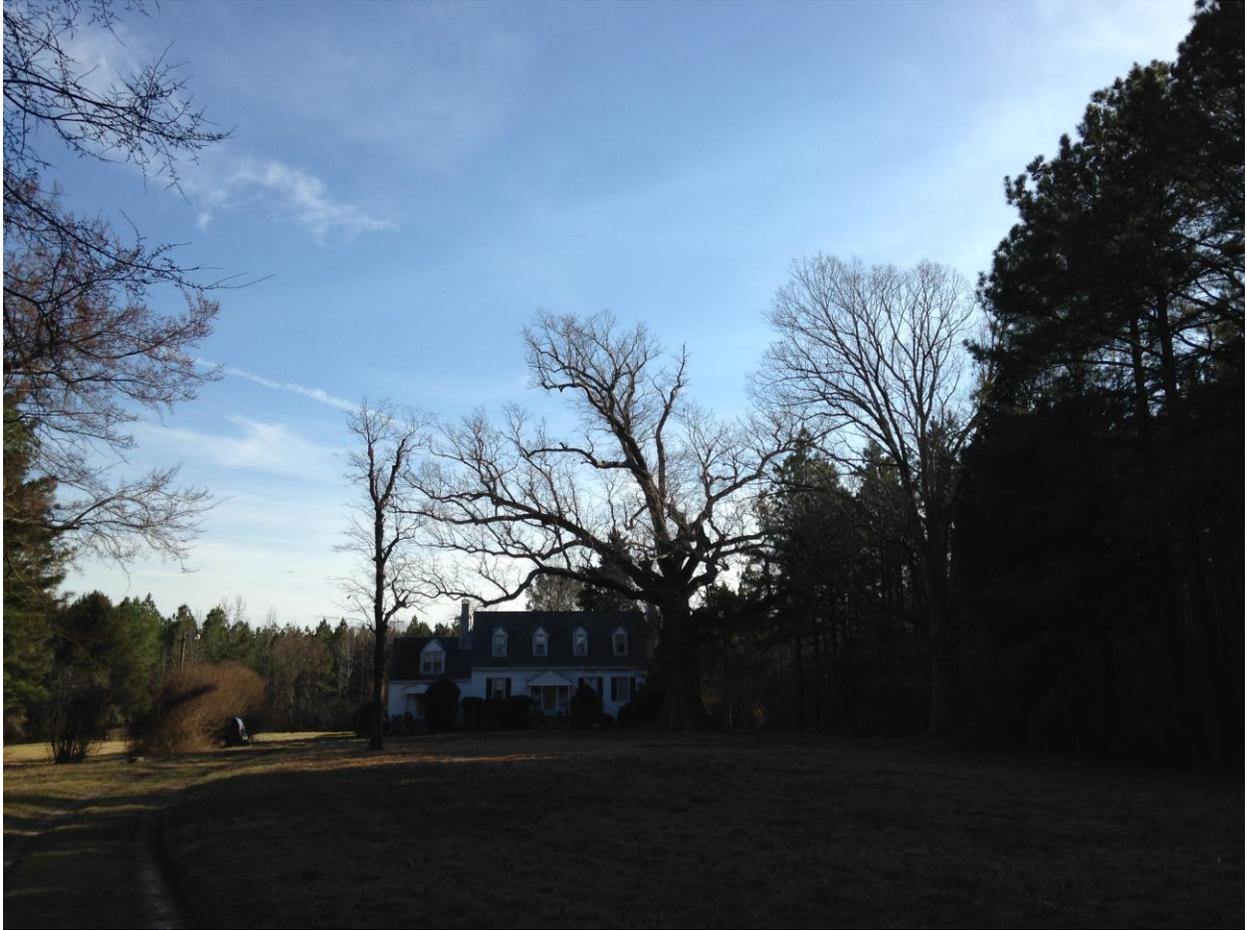
A broad base supported a wide spread, and though many leaders were lost, one remained, and reached a respectable height. Your eyes automatically fill in the blanks, imagining what this *Quercus alba* could have been. But the tree before you, with its roots, flare, trunk and crown, is the scope of the job.

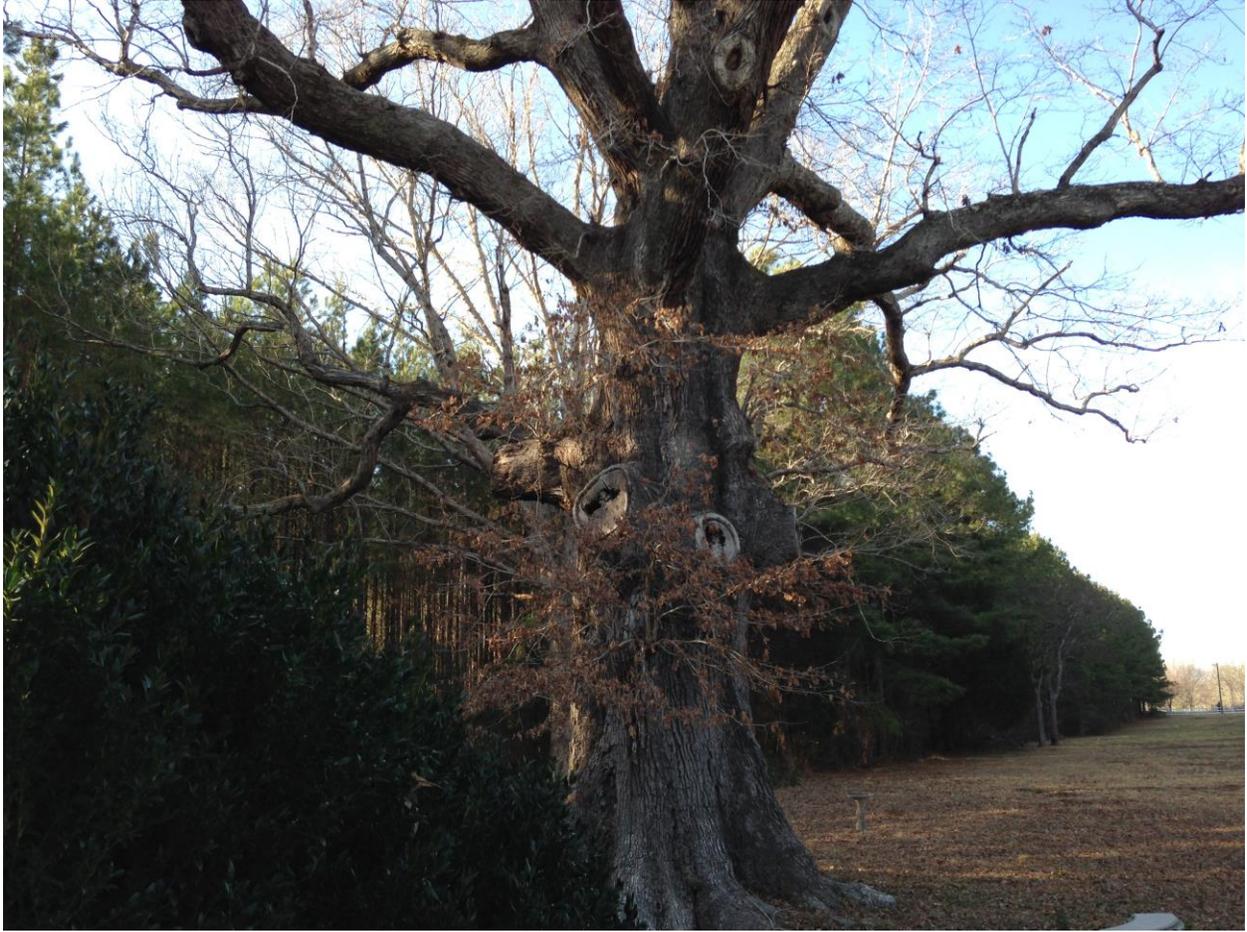
Crown damage may have been caused by overengineered cables, but this work was likely done before there was a national standard for supplemental support. This leader lost its ends after the cable held it rigid. For present purposes there is no maintenance required, other than to avoid the area under the dead stub. New growth looks vigorous outside the shade from the pines. One-third of the suppressing pines should be removed every 3 years.

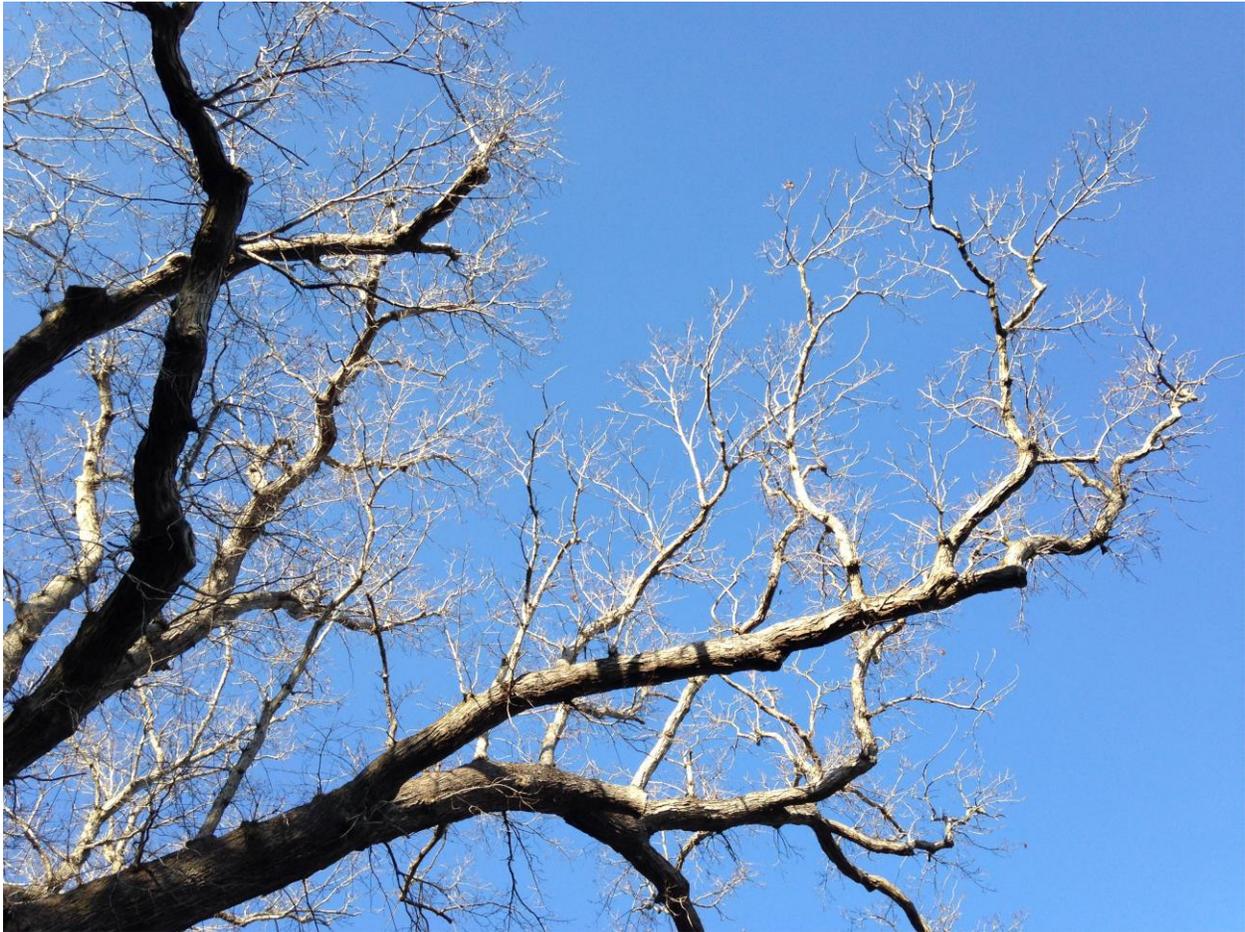
Behind natural breaks and natural reduction cuts, apical influence spreads from inner terminals, each reiterating natural tree form and harvesting sunlight, as nature intends. Very little energy is wasted, each twig positioned to do its job, and do it well. Observe the natural form and the future potential of these branches. The tree knows what it is doing; it is we who must learn.
